The Ranches HOA

Level II Reserve Study

Report Period – 1/01/08 – 12/31/08

Client Reference Number 10329
Property Type Single Family Homes
Number of Units 1,750
Fiscal Year End December 31
Date of Property Inspection August 23rd, 2007
Inspector Robert Forney

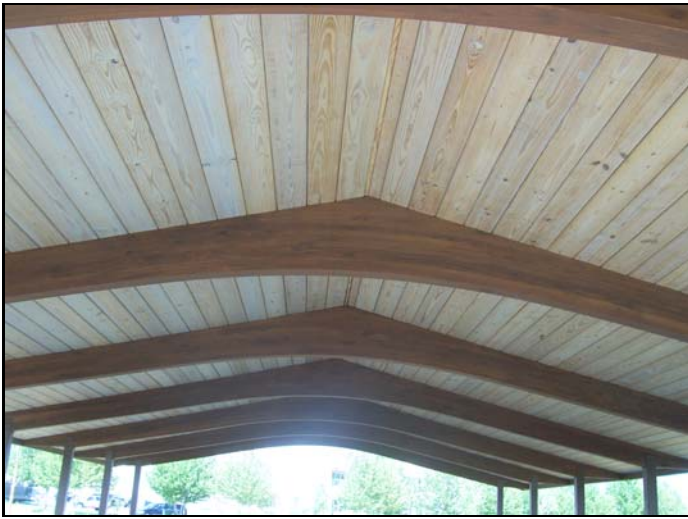
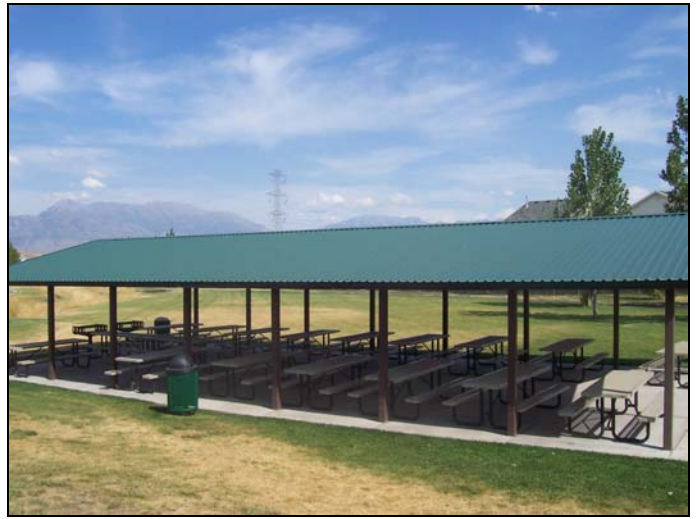
Comp #: 105 Pavilion Roof - Repair

No deterioration noted. No expectation to completely replace roof. We recommend funding to make periodic repairs. Seal wood regularly as an operating expense to protect wood.

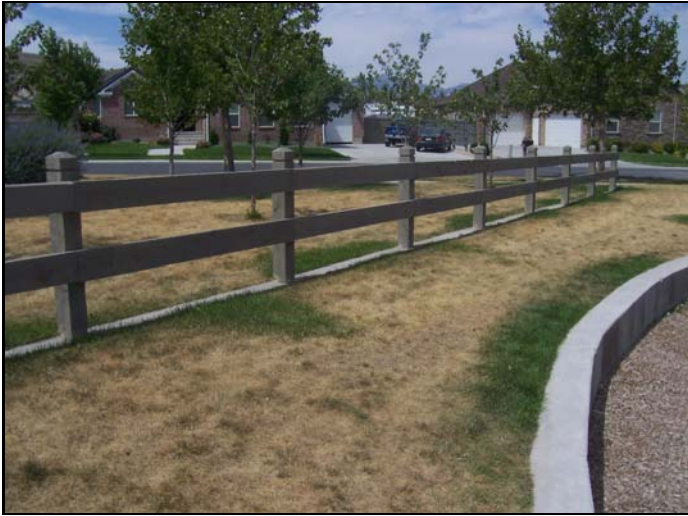
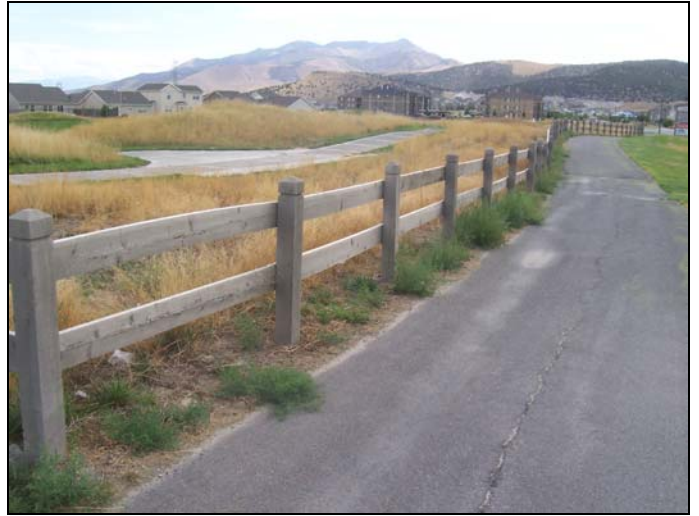
Comp #: 209 Wood Fencing - Stain

Reported that these surfaces were stained in 2005. No problems noted at the time of inspection. We recommend staining the fencing approximately every 5 years to protect wood and ensure full life.

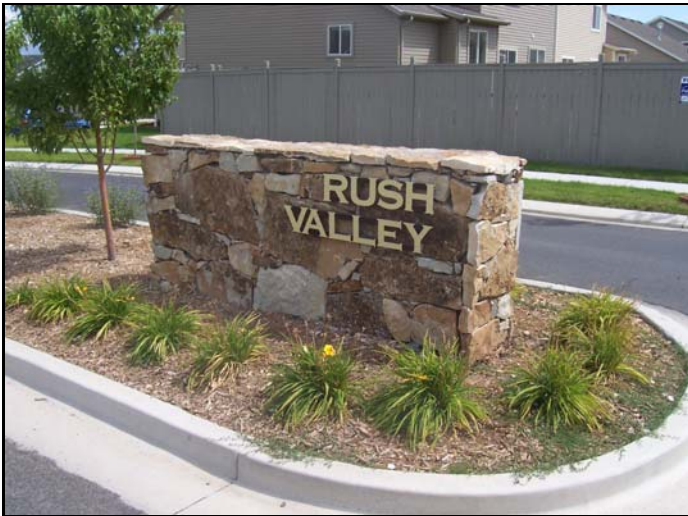
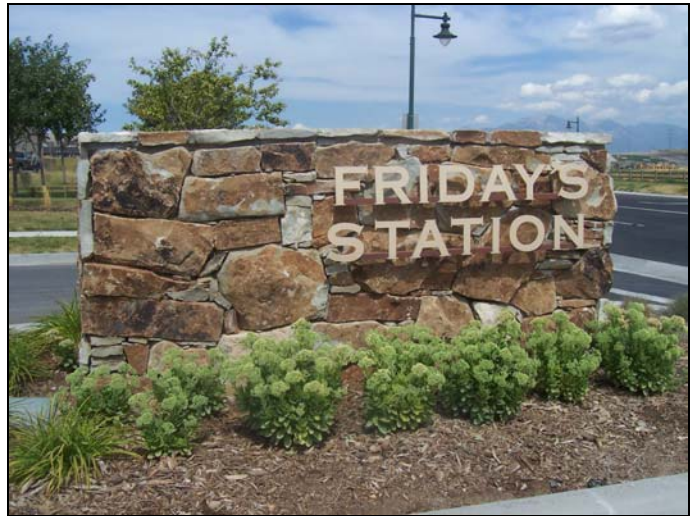
Comp #: 801 Monuments - Re-Letter

No rusting or pitting. Although this component may reach and extended life we recommend funding to completely replace the monument sign letters approximately every 15 years to ensure appearance.

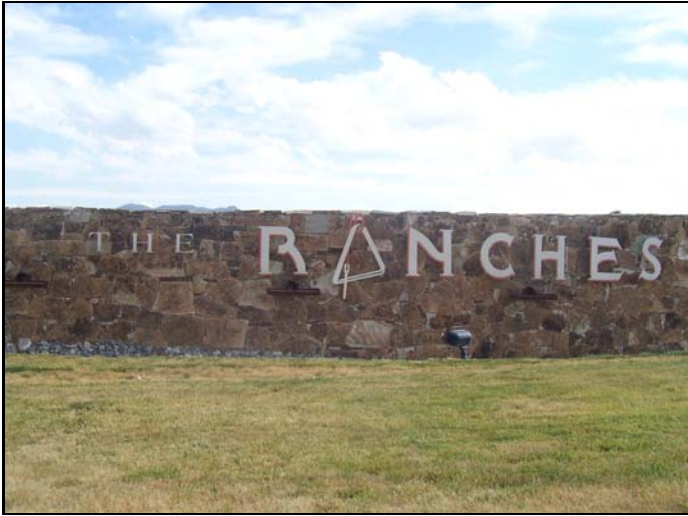
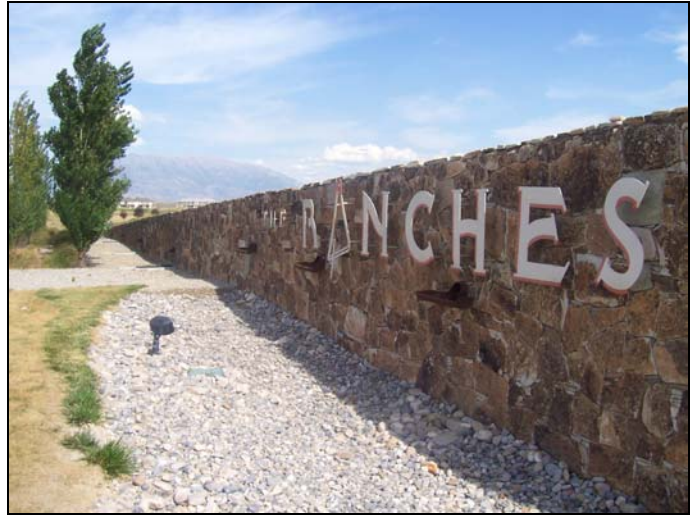
Comp #: 802 Main Monument Sign - Re-Letter

Letters are in good condition. We recommend funding to completely replace letters approximately every 18 years to ensure appearance and keep up with current decorative tastes. Remaining life based on current age and condition.

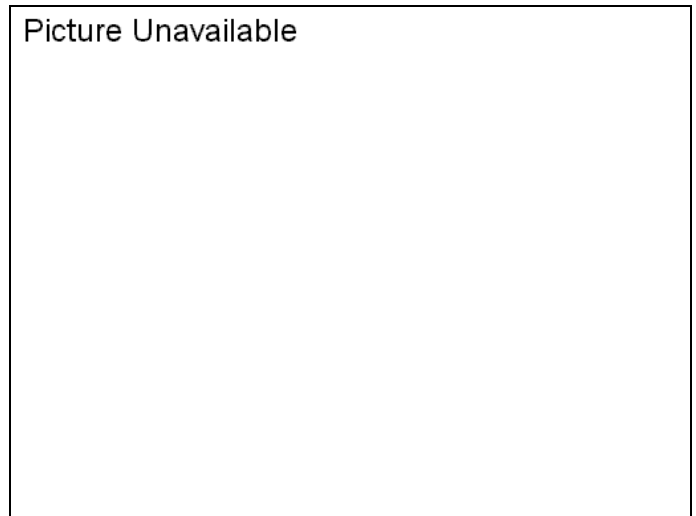
Comp #: 805 Wood Direction Signs - Replace

No problems noted at the time of inspection. Recommend maintaining these signs as an operating expense or along with Comp# 808 Street Signs - Replace. No separate reserve funding necessary.

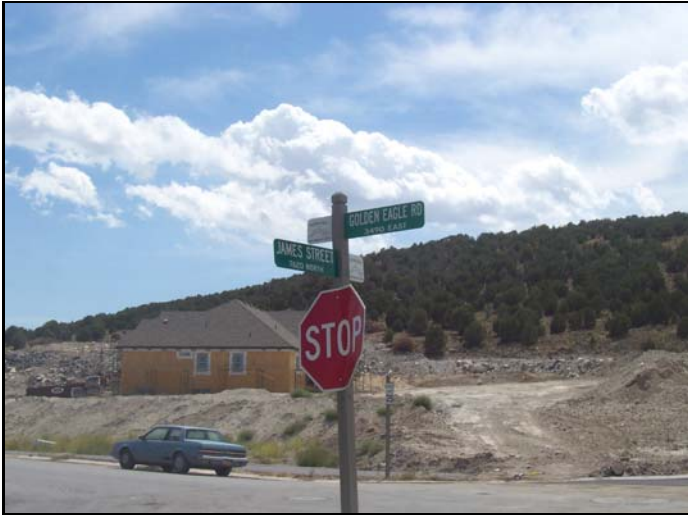
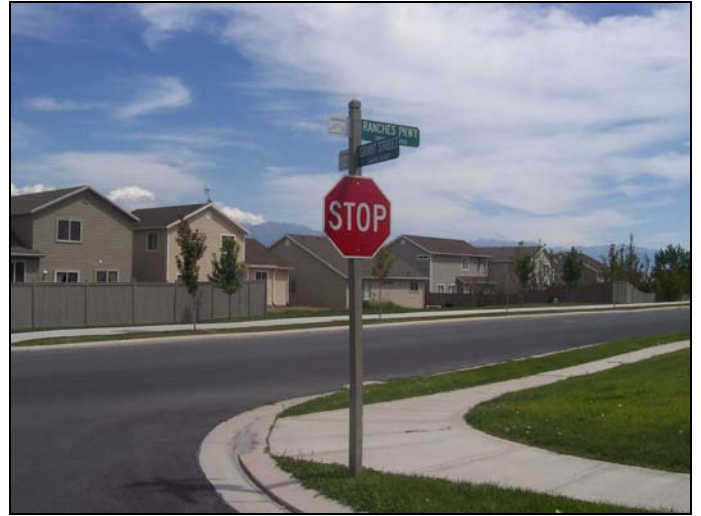
Comp #: 808 Street Signs - Replace

No expectation to replace all signs at one time. Recommend reserving to replace 15% of signs approximately every 5 years.

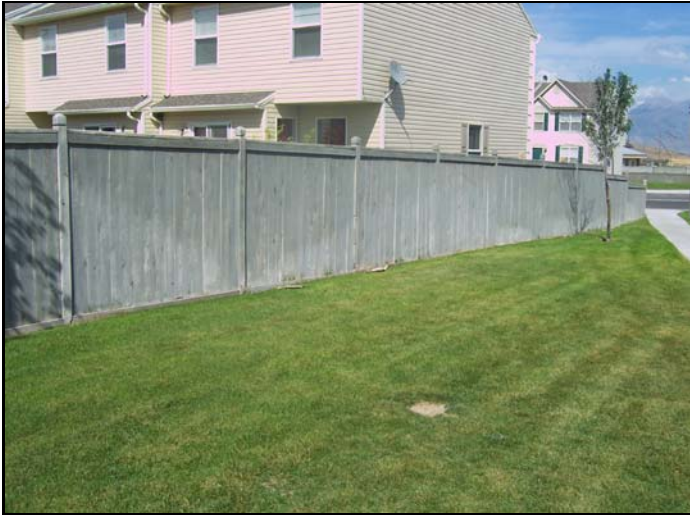
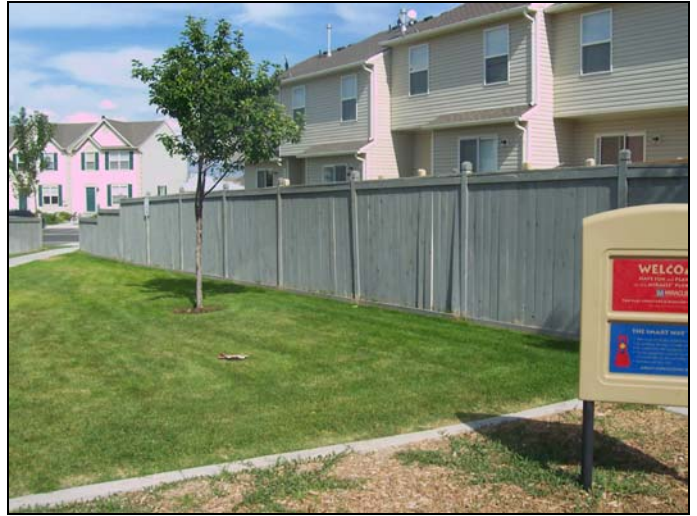
Comp #: 1001 Privacy Fencing - Replace

No leaning or structural problems noted. With regular sealing expect a useful life of approximately 16 years from this type of fencing. Stain fence regularly (see Comp# 209 Wood Fencing - Stain) to ensure full life.

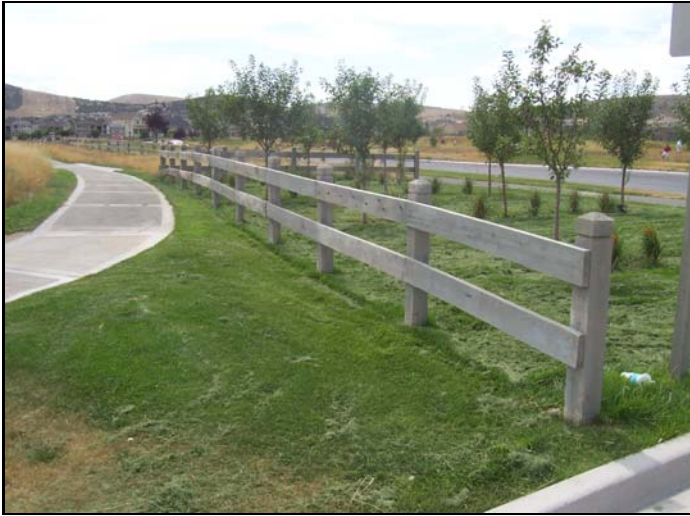
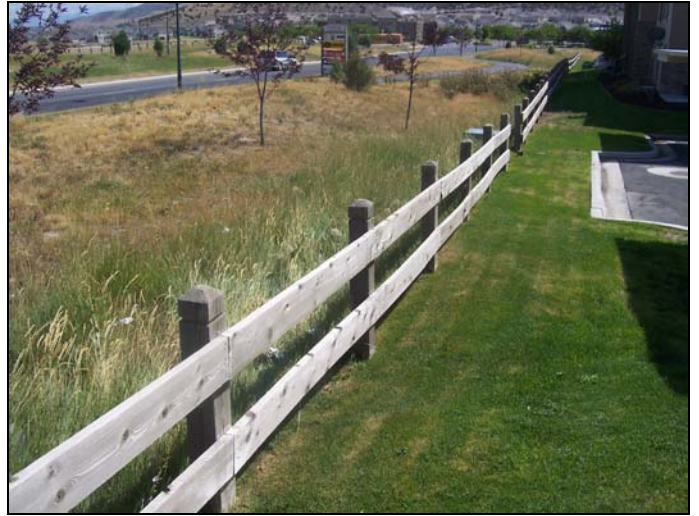
Comp #: 1009 Rail Fencing - Partial Replace

Fencing is in good condition. No deterioration or stability problems noted. This fence has a relatively long useful life, no expectation to replace all fencing at one time. We recommend funding to make periodic repairs.

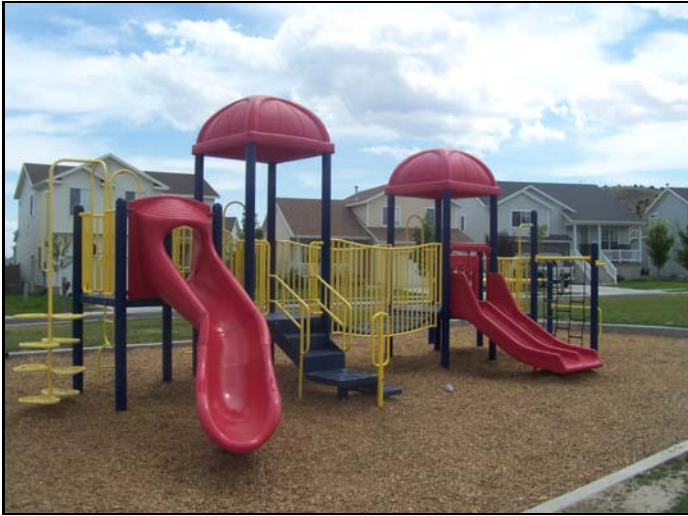
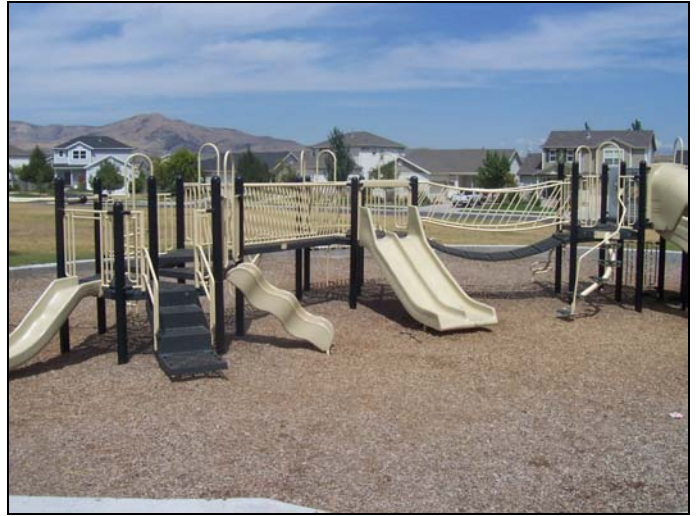
Comp #: 1301 Play Structures - Replace

No significant problems noted, no advanced signs of wear observed. We recommend funding to replace these structures approximately every 18 years. Remaining life based on average age.

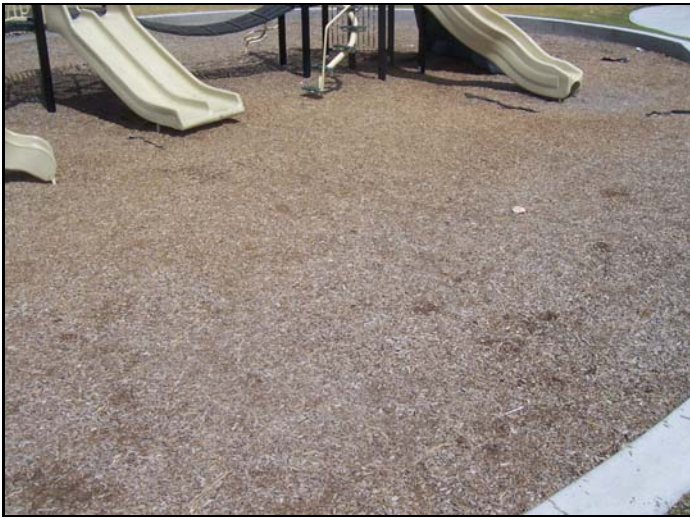
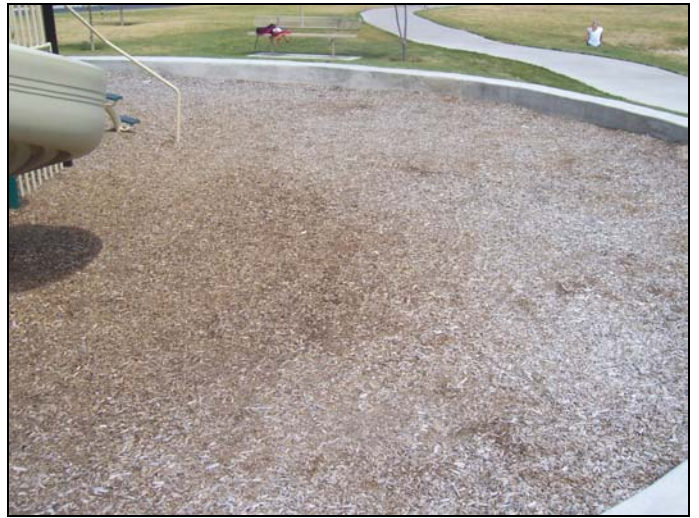
Comp #: 1303 Tot Lot Groundcover - Refill

No problems noted at the time of inspection. Due to minimal cost maintain this component as an operating expense. No reserve funding necessary.

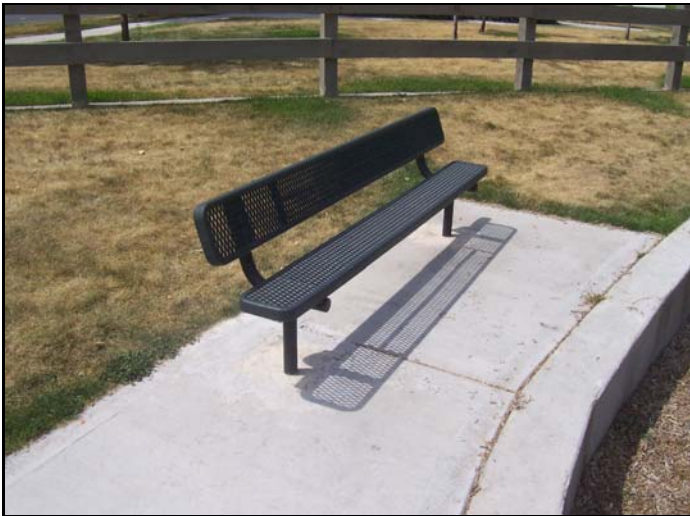
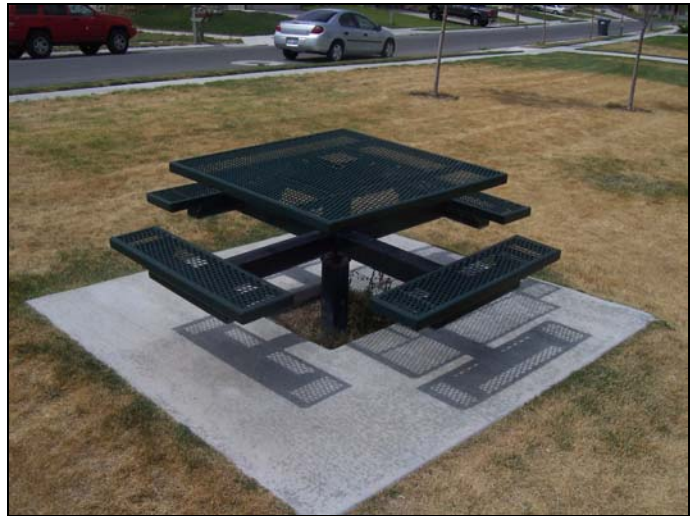
Comp #: 1306 Park Furniture - Replace

No sun damage or appearance concerns noted. We recommend funding to replace this furniture approximately every 12 years. Make local repairs and replacements as necessary as an operating expense to ensure full life.

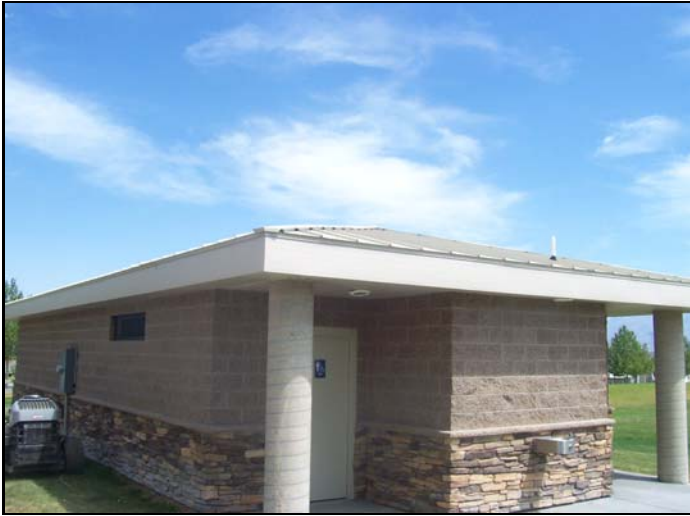
Comp #: 1413 Restrooms - Remodel

Reported that these restrooms are the responsibility of the city. No reserve funding necessary.

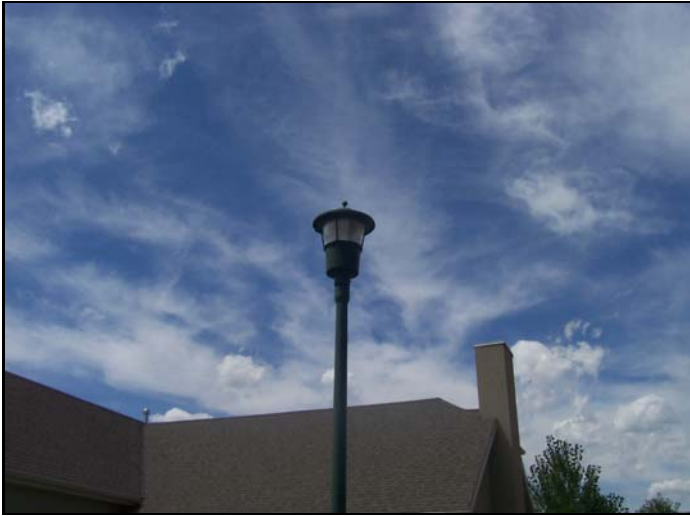
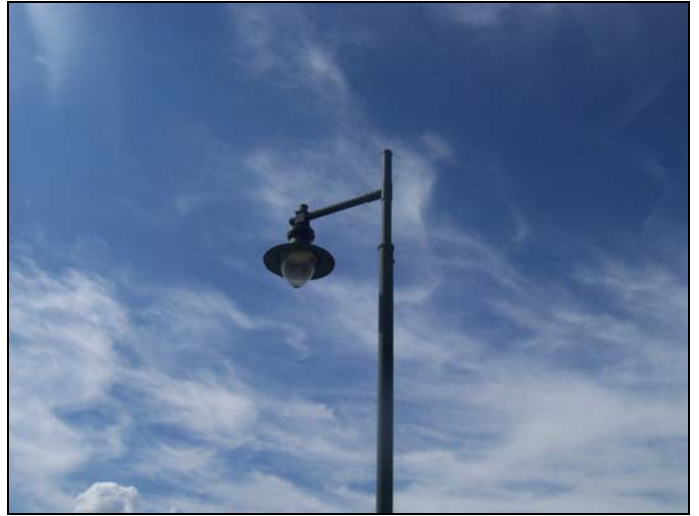
Comp #: 1604 Pole Light Fixtures - Replace

Reported that these lights are the responsibility of the city. No reserve funding necessary.

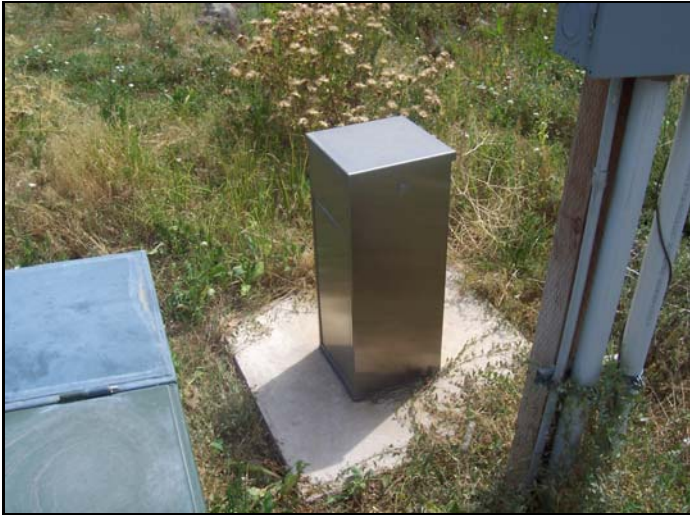
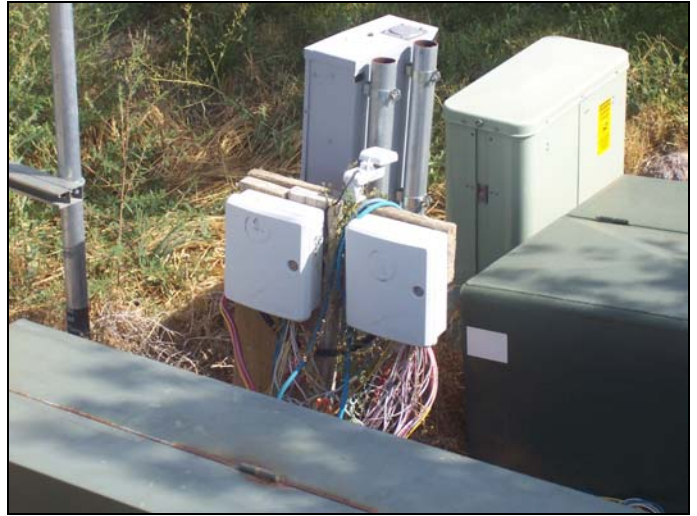
Comp #: 1703 Irrigation Time Clocks - Replace

No expectation to replace all clocks at one time. Reserve to replace approximately ten clocks every three years.

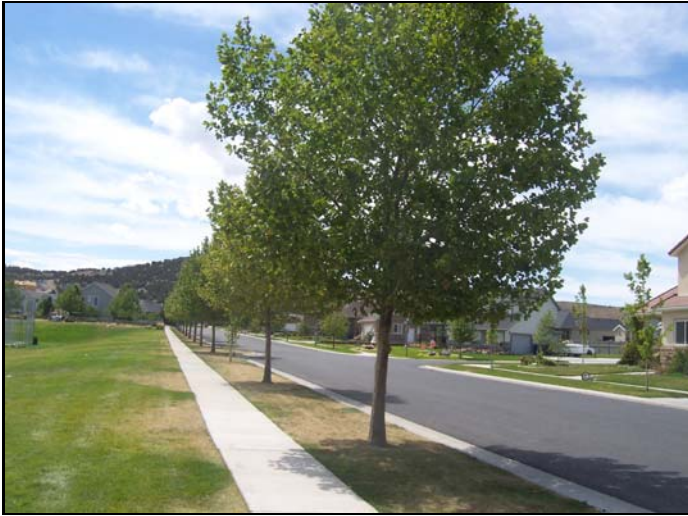
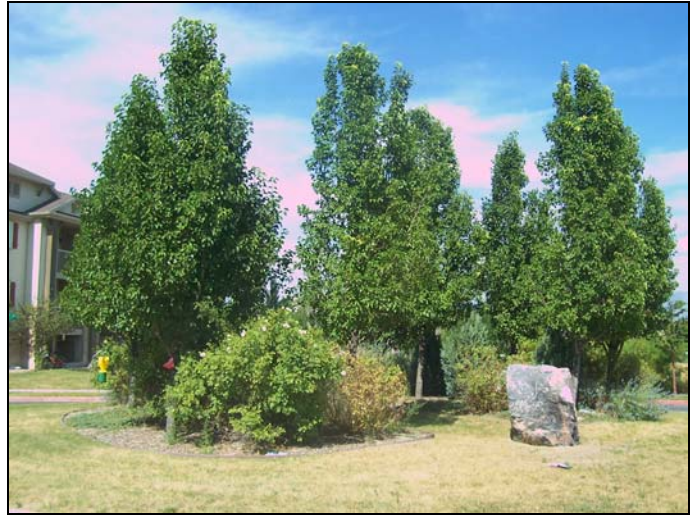
Comp #: 1804 Tree - Replacement

No expectation to replace all trees at one time. Reserve to replace approximately 5% of total trees every 5 years.

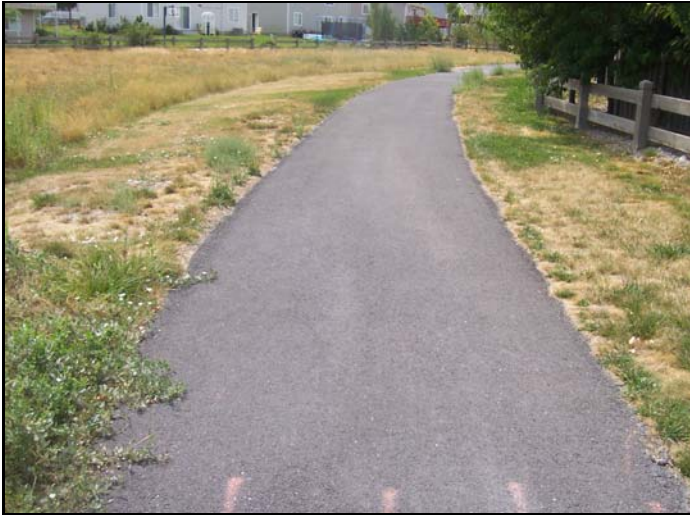
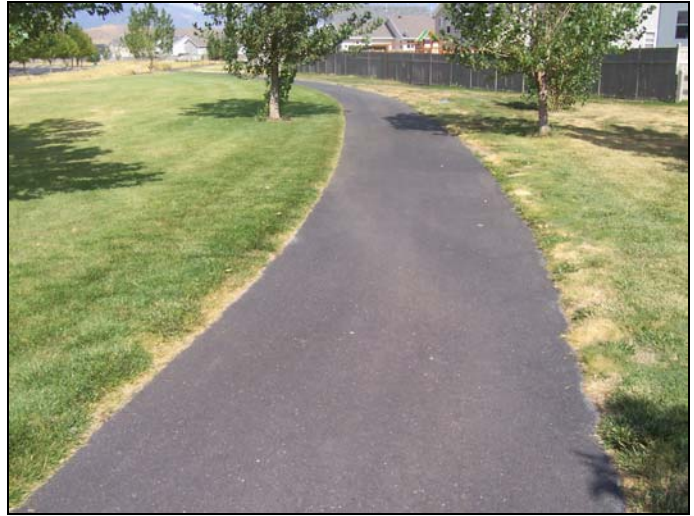
Comp #: 1807 Asphalt Path - Overlay

No significant cracking or structural problems noted at the time of inspection. Because these asphalt surfaces do not carry vehicle traffic these asphalt paths should only require an overlay approximately every 25 years. Make local repairs as necessary at the same time as sealing (see Comp# 1807 Asphalt Path - Seal) to ensure full life.

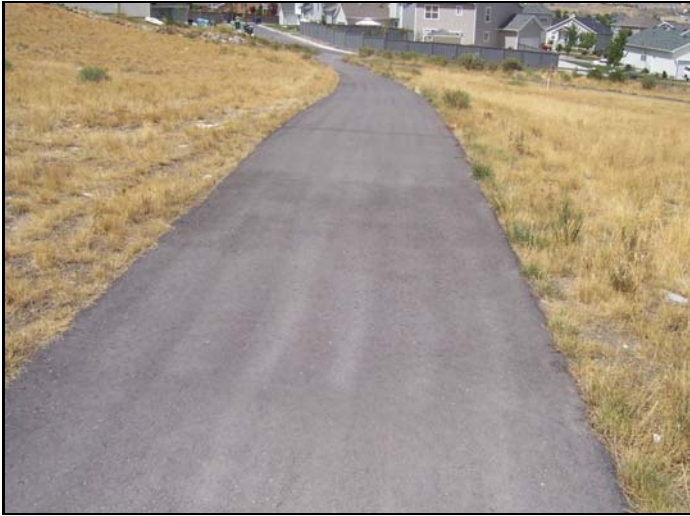
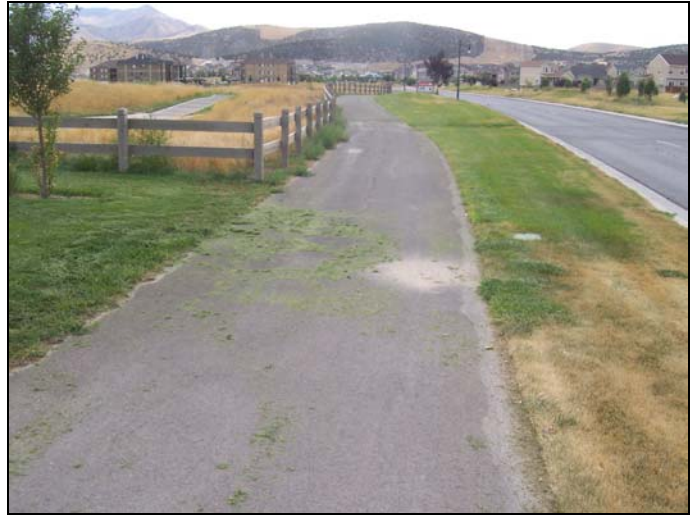
Comp #: 1808 Asphalt Path - Seal

Asphalt paths are in good condition. No significant cracking or settling noted. Seal asphalt approximately every 6 years to protect asphalt surface and prevent premature overlay (see Comp# 1807 Asphalt Path - Overlay).

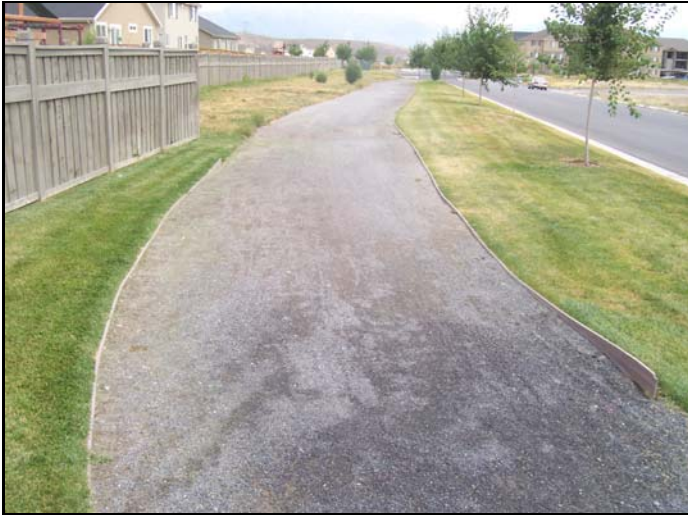
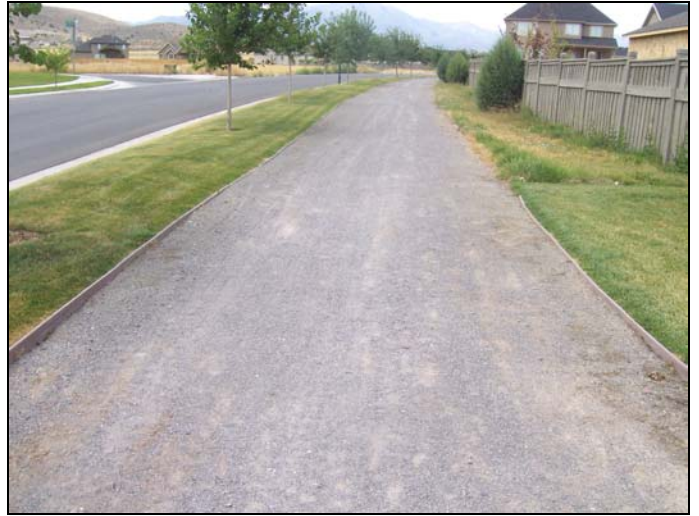
Comp #: 1809 Horse Paths - Refurbish

Due to minimal use we recommend refilling sand and generally maintaining these paths as an ongoing landscaping issue. No reserve funding necessary.
